# Dwyer Case History

**Project Name:** Target

**Project Type:** Underpinning, Steel Piering

**Location:** Cincinnati, OH

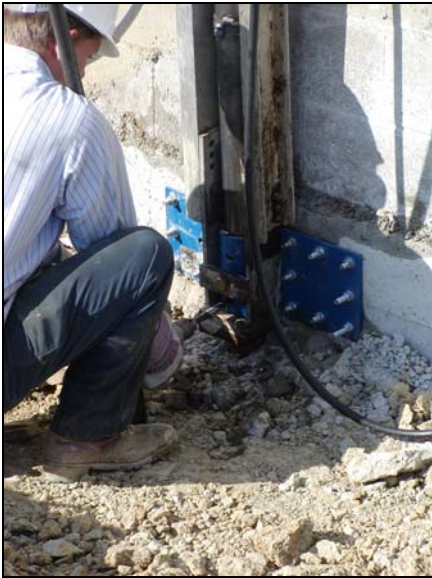
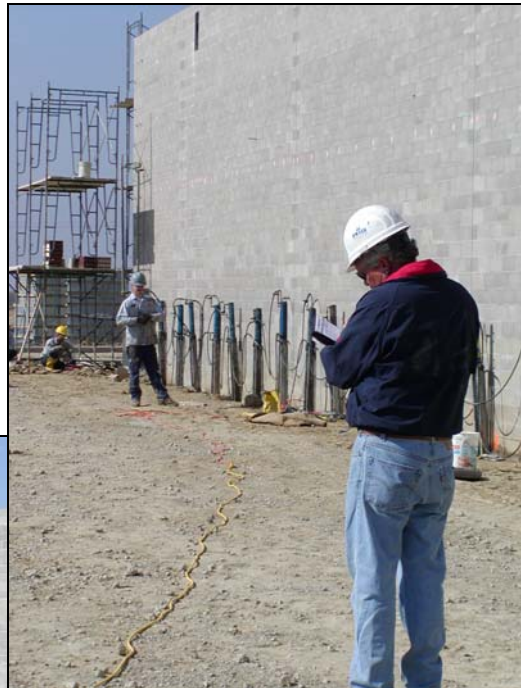
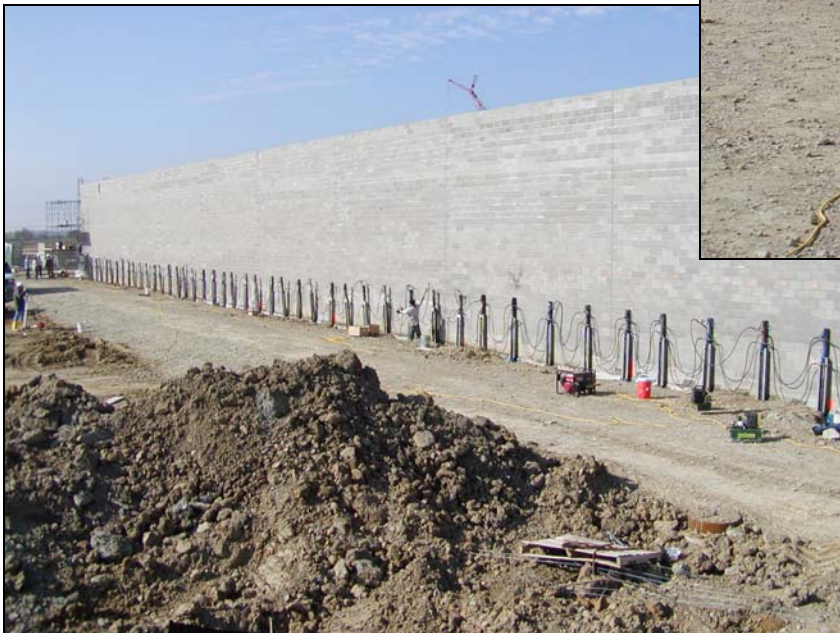
The 100,000 sf department store project had two failed foundations on the north and south block walls, which caused both walls to roll outward. A total of 110 piers were installed on 250' of the south wall that settled 1.5", and 330' of the north wall that settled 2.5". The walls were successfully lifted and stabilized in 7 days. This kept the project on track and saved hundreds of thousands of dollars in delays and replacement costs.
